June 28, 2019
File No. 262018.063

Subject: Department of Natural Resources Washington Geological Survey,
School Seismic Safety Assessment Project, Contract No. AE 410 -
Seismic Evaluation for **Mount Baker School District**

School Buildings Evaluated in the Mount Baker School District

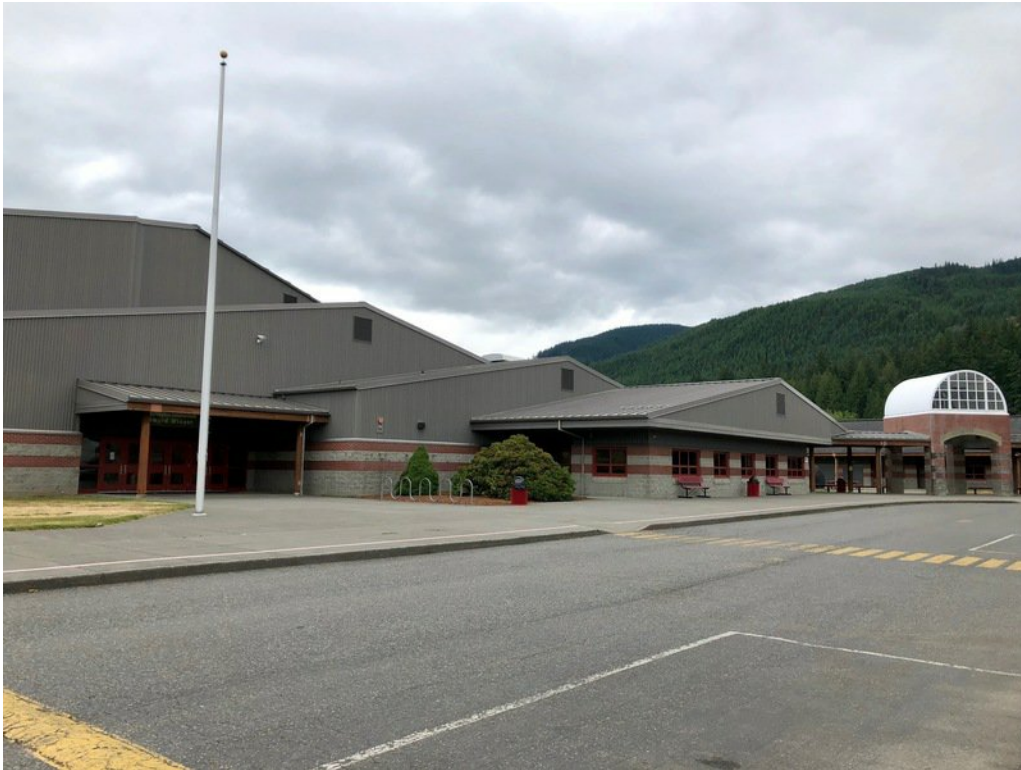
Figure 1-1. Exterior east side of building.

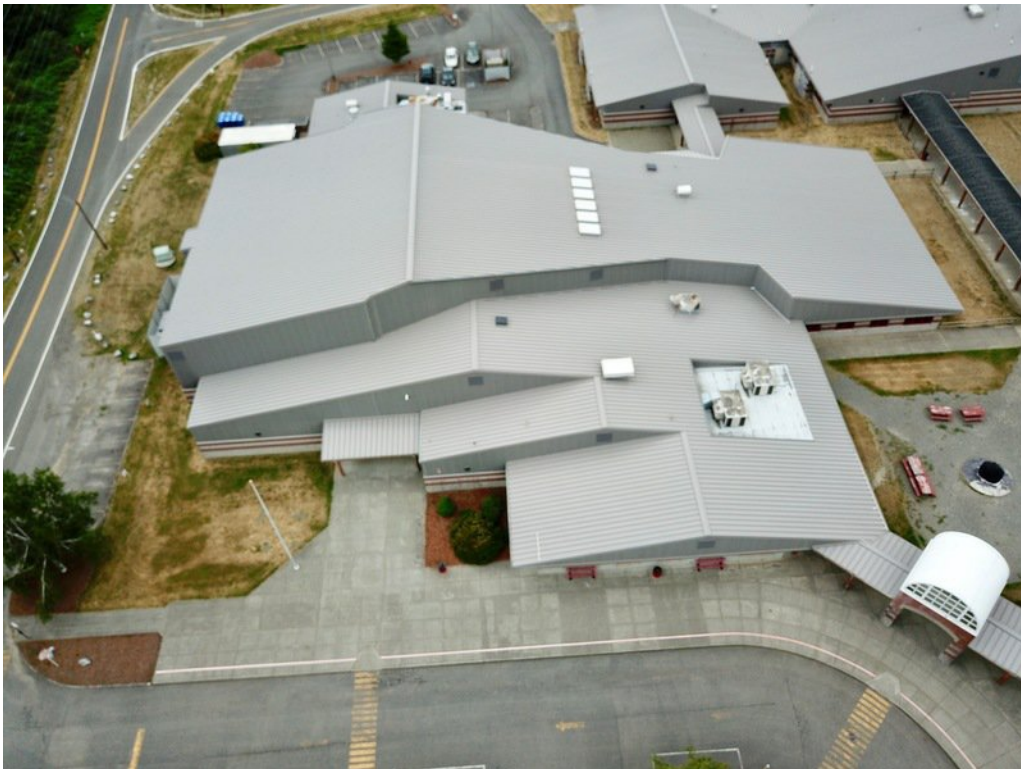
Figure 1-2. Exterior east side of building.

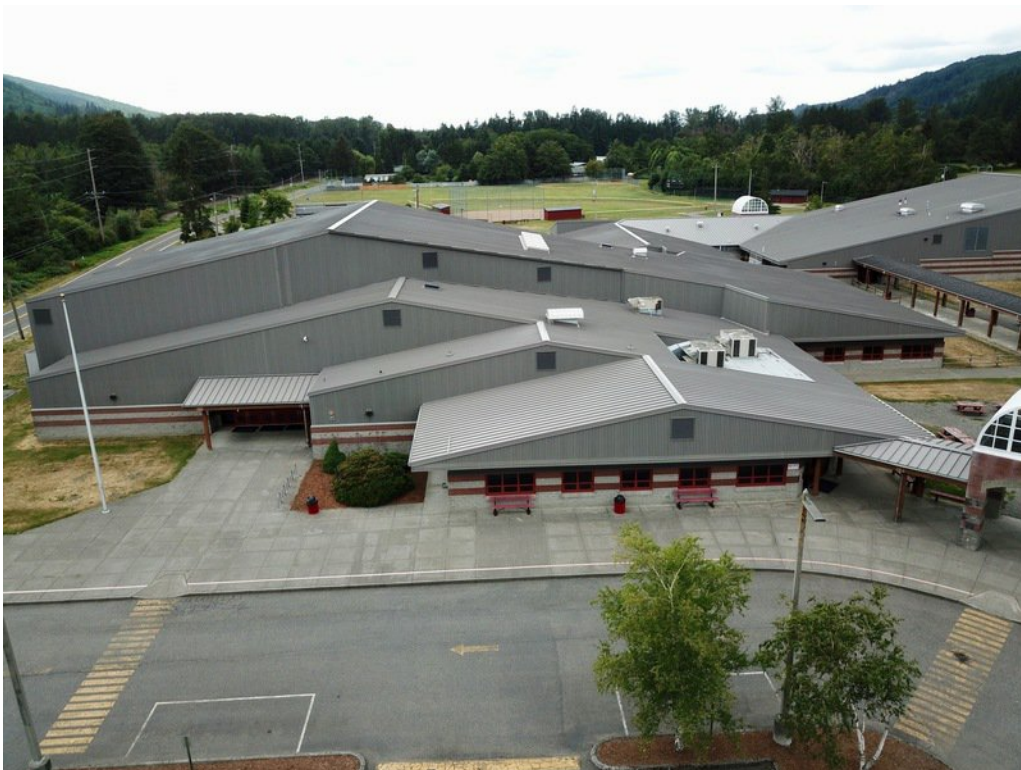
Figure 1-4. Exterior east side of building.

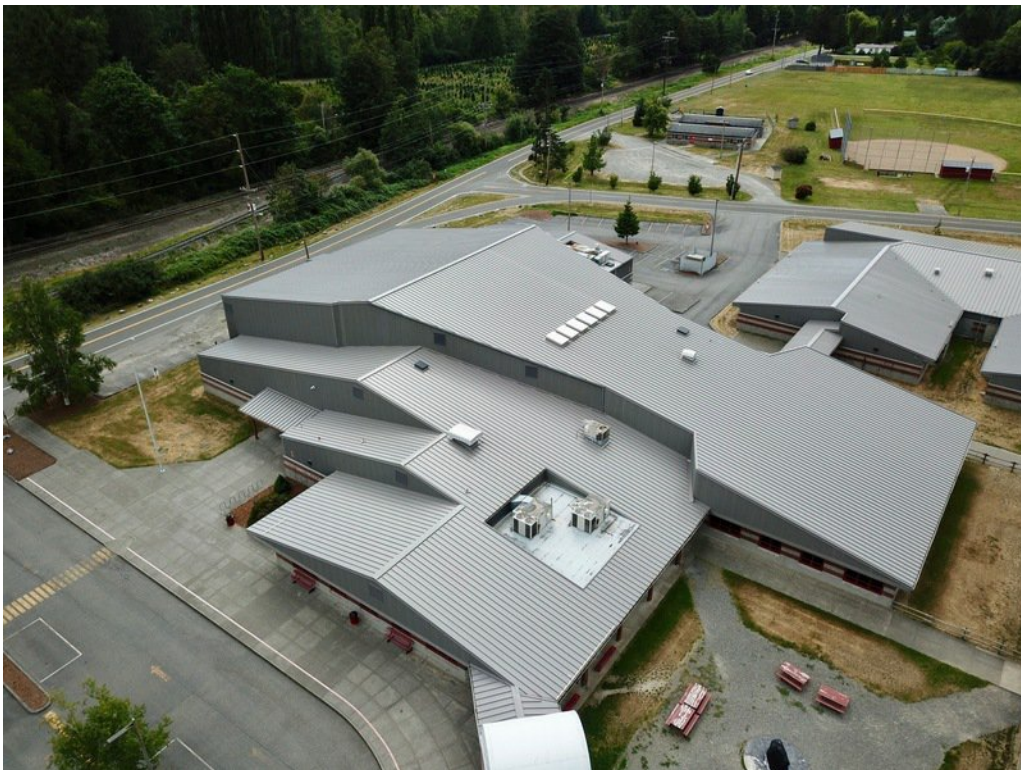
Figure 1-6. Exterior northeast corner of building.
